# Summit Demolition Services LLC

## WORKPLACE INSPECTION REPORT

### Daily Demolition Site Inspection

| <div>ESTABLISHMENT</div> <div><b>Summit Demolition — Dallas (HQ)</b></div> <div>2410 Irving Blvd · Dallas, TX, 75207</div> | <div>PROJECT / JOBSITE</div> <div><b>Midtown Tower Interior Strip-Out</b></div> <div>Job # 3-2101</div> <div>1445 Ross Ave, Dallas, TX</div> | <div>DATE</div> <div><b>08/18/2026</b></div> <div>Started: 08:00 AM</div> |

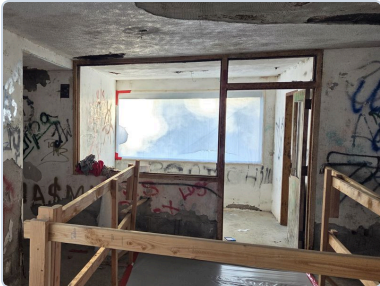
| ITEM | RESULT |
|---|---|
| 3. Floor openings from material drops covered or guarded<br>1926.501(b)(4)<br><br>Material-drop opening guarded and<br>sheeted — verified | Pass |

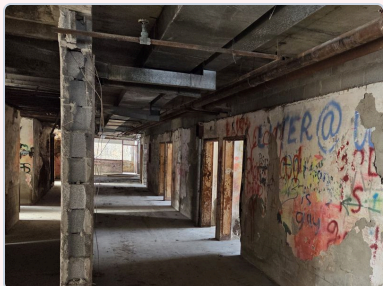
| ITEM | RESULT |
|---|---|
| <p>1. Water supply for dust suppression operating at all cut/drop points<br/>1926.1153(c)<br/><i>Water line to 4th-floor cut station disconnected; visible dust at drop point.</i></p> <p>Level 4 cut station — supply line found disconnected at riser</p> | Fail |

| # | FINDING | STANDARD | SEVERITY | ASSIGNEE | DUE | STATUS |
|---|---|---|---|---|---|---|
| 1. | Water supply for dust suppression operating at all cut/drop points<br>Section: Silica & Dust Control. Water line to 4th-floor cut station disconnected; visible dust at drop point. | <a href="#">1926.1153(c)</a> | High | Site Foreman | 08/25/2026 | Open |

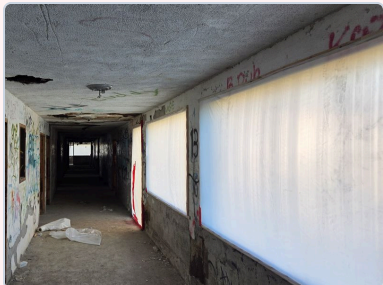
| ITEM | RESULT |
|---|---|
| <p>4. Housekeeping: accumulated dust and debris controlled<br/>1926.25<br/><i>Accumulated demolition dust on stair landings, levels 3-4.</i></p> <p>Debris and poly accumulation, level 3 corridor at stair landing</p> | Fail |

| # | FINDING | STANDARD | SEVERITY | ASSIGNEE | DUE | STATUS |
|---|---|---|---|---|---|---|
| 2. | Housekeeping: accumulated dust and debris controlled<br>Section: Silica & Dust Control. Accumulated demolition dust on stair landings, levels 3-4. | <a href="#">1926.25</a> | Medium | Site Foreman | 08/25/2026 | Open |
